**Los Angeles County
Metropolitan Transportation Authority
Office of the Inspector General**

**Review of Transit Station and Park & Ride
Maintenance and Parking Utilization**

Report No. 12-AUD-04

February 3, 2012

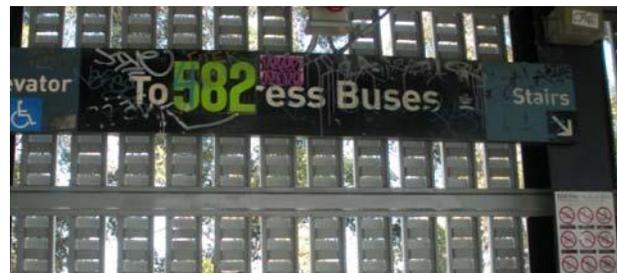
a. Grffiti: Graffiti is unsightly and negatively impacts Metro’s image. We found graffiti at five transit stations: Artesia and Slauson (Blue Line); Avalon (Green Line); and Los Angeles Country/USC Medical Center and Manchester (Silver Line). Station walls, signs, and elevators had been defaced by spray paint.

Photograph 1. Graffiti at LA Country/USC Medical Center Station.

As previously mentioned, FMCA manages the contract for graffiti removal. The contractor’s 13 member abatement team makes daily visits to each transit station checking for graffiti. The contracted staff are also notified of issues from the “trouble desk” (a Metro hotline for complaints) or from four FMCA supervisors who make weekly inspections of random transit stations. The contracted staff must remove graffiti within 48 hours of it being reported. Graffiti removal that requires paint cover up for the Orange and Silver Lines are handled internally by the PMPG. FMCA officials stated the vandals are relentless. After removing graffiti one day, the vandals may return that night and spray again.

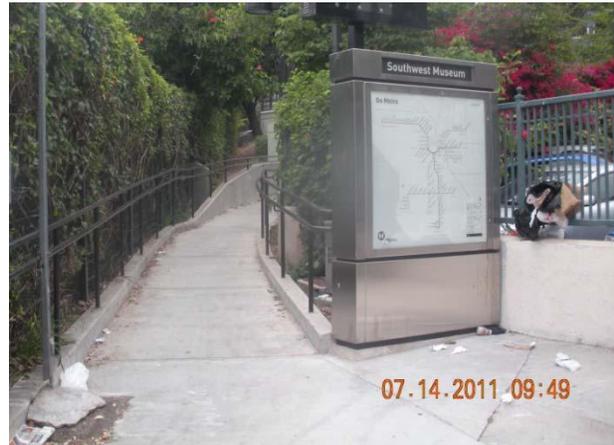
b. Trash: Trash is unsanitary and unsightly and could be a “trip or slip” hazard. We found excessive amounts of trash at three stations. At Southwest Museum Station (Gold Line), the trash was at the entrance of the station, and at Imperial/Wilmington Station (Green Line), debris was on a station building roof that was visible to patrons taking the stairs. Artesia Station (Blue Line) had trash in the landscaping.

Photograph 2. Trash at the entrance of the Southwest Museum Station.

The custodial staff on-site is responsible for trash pick-up at all the stations in the non-landscaped areas. Custodial staff work in three shifts. Each shift is required to look for and remove trash from the station. The trash we found at Southwest Museum and Imperial/Wilmington Stations may have been placed there by patrons between cleanings. FMCA manages contracts for landscaping services which includes the removal of trash from landscaped areas. The contracted staff are assigned to the stations and come once a week. A FMCA official suspects the trash in the landscape was placed there between visits.

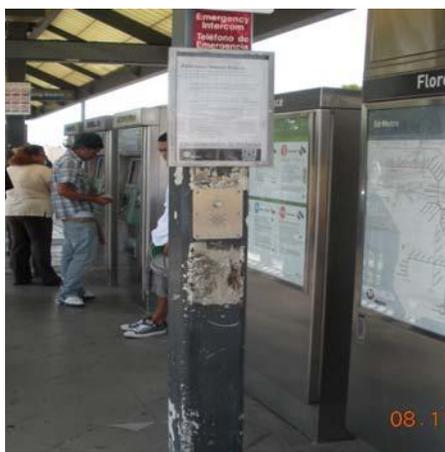
Photograph 3. Chipped paint at the Florence Station.

The chipped paint had not been called in before our review. After we informed a Property Maintenance official about the pole, he generated a work order and plans to have it painted soon.

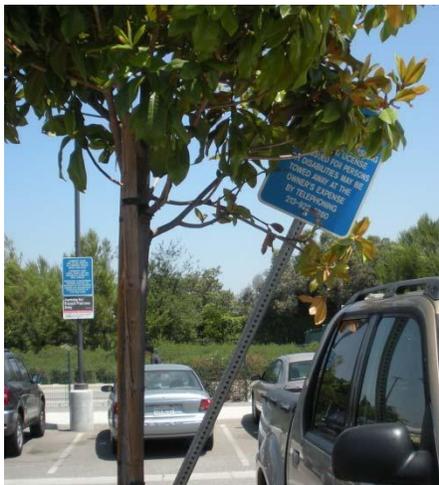
Photograph 4. Damaged sign at the Reseda Station park & ride.

- A disabled person parking sign was leaning and possibly ready to fall at the Orange Line’s Reseda Station park & ride owned by Metro. At the same location, another disabled person parking sign was missing. A stub in the ground where the sign once stood was still there. RFM handles signage issues in the Metro-owned park & rides. RCS has 10 general service supervisors who conduct random inspections of the transit stations and Metro-owned park & rides and inform RFM of issues. The issues we identified may have occurred between supervisory visits or may have been overlooked. We brought these issues to a RFM official’s attention. He has since reported that the leaning sign has been fixed and that he plans to correct the issue of the missing sign.

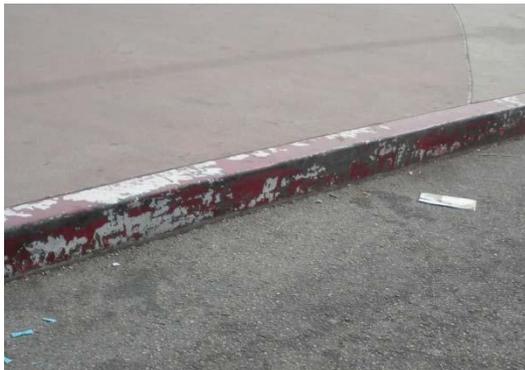
Photograph 5. Faded paint on a curb at the North Hollywood Station park & ride.

- At the Red Line's North Hollywood Station park & ride which is owned by Metro, the paint on one curb was severely faded, and it was difficult to distinguish whether the curb was red (no parking), white (unloading), or gray (parking allowed). As previously discussed, PMPG is made aware of paint issues through the trouble desk or random supervisory inspections. This issue we identified had not been reported to the PMPG. However, after we brought it to their attention, they generated a work order and plan to correct the problem.

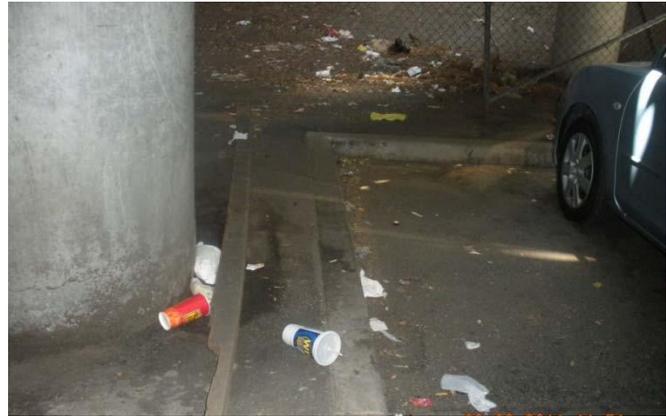
d. Trash: The presence of trash in the parking lots is unattractive and should be removed. We found excessive amounts of trash at the Green Line's Norwalk Station and Long Beach Station park & rides (both owned by Caltrans).

Photograph 6. Trash at the Long Beach Station park & ride.

Metro custodial staff do not clean park & rides that are not owned by Metro. However, if enough complaints are received and Caltrans does not respond, the custodial staff will do the clean up.

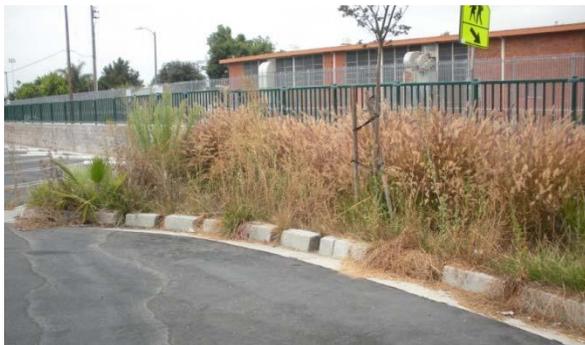
Photograph 7. Overgrown grass at the 103rd Street Station park & ride.

- The Blue Line's 103rd Street Station park & ride (owned by CRA/LA) had overgrown grass and shrubs surrounding the parking lot.

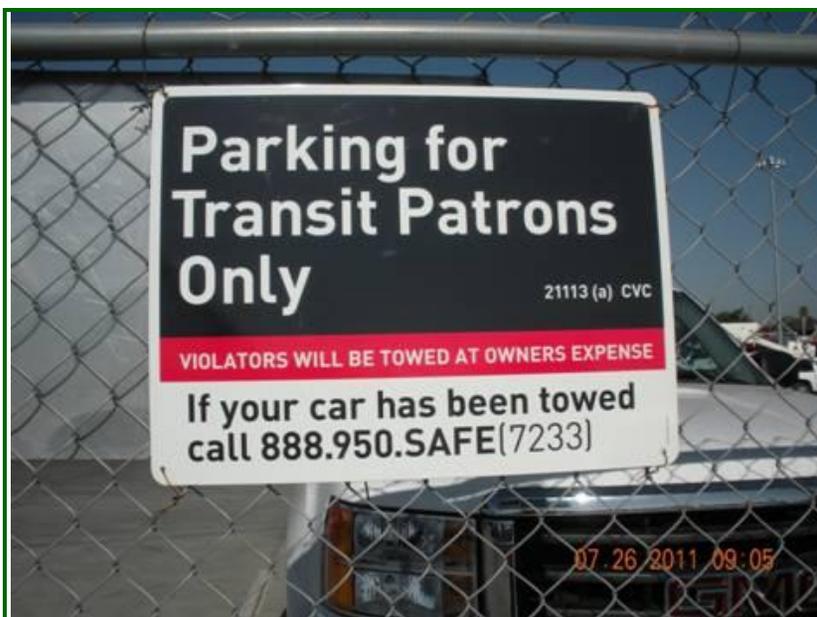
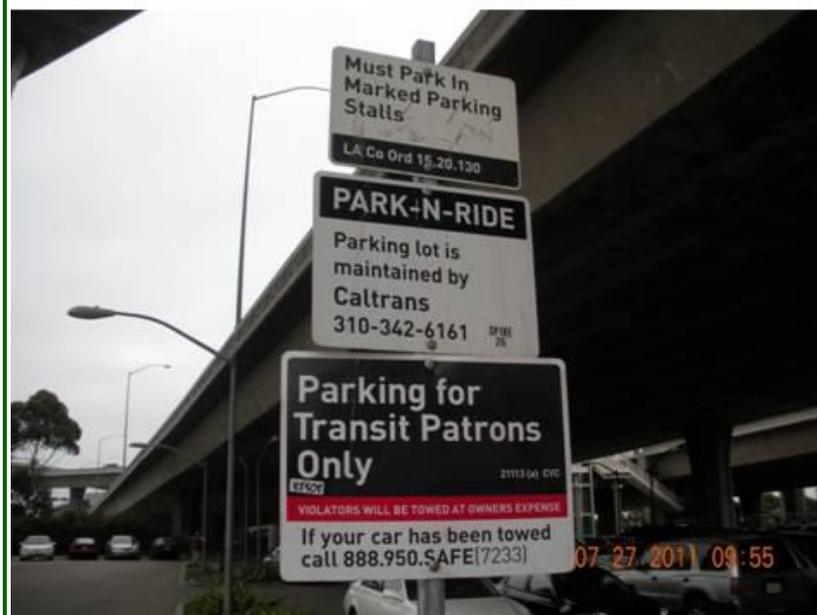
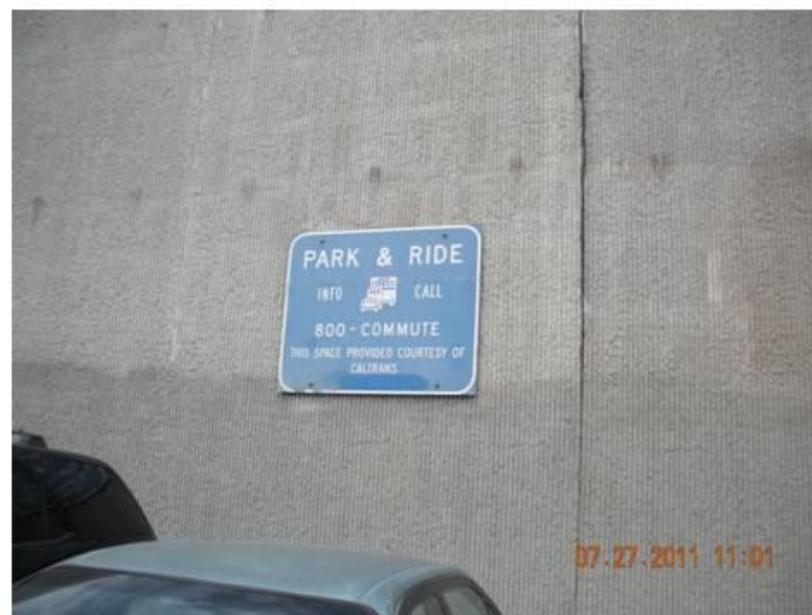
Park and Ride Signage

(Top left picture) Sign states "Parking for Transit Patrons Only"

(Bottom left picture) Shows three signs; top sign states "Must Park In Marked Parking Stalls," middle sign states "Park-N-Ride, Parking lot is maintained by Caltrans," bottom sign states "Parking for Transit Patrons Only"

(Bottom right picture) Sign states "Park & Ride Info Call 800-Commute, This Space Provided Courtesy of Caltrans"

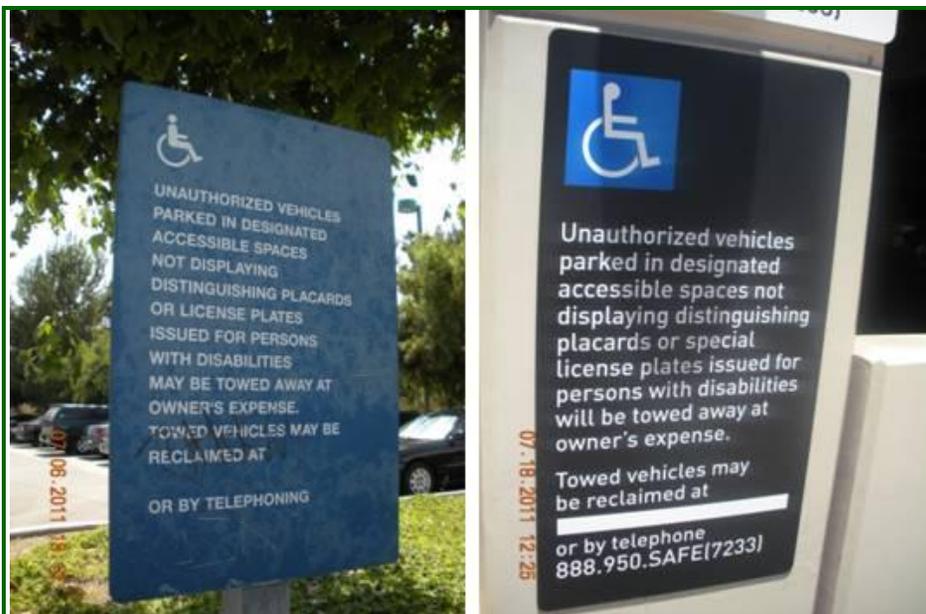
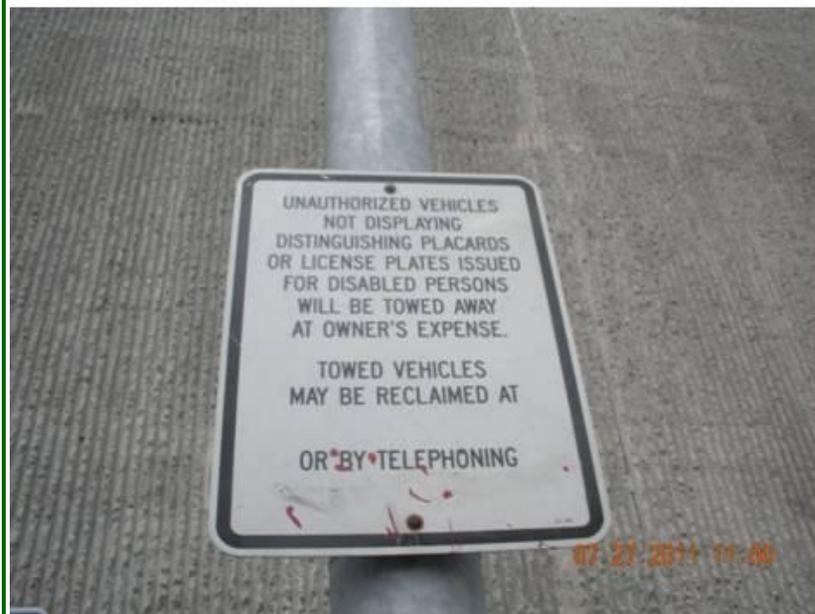
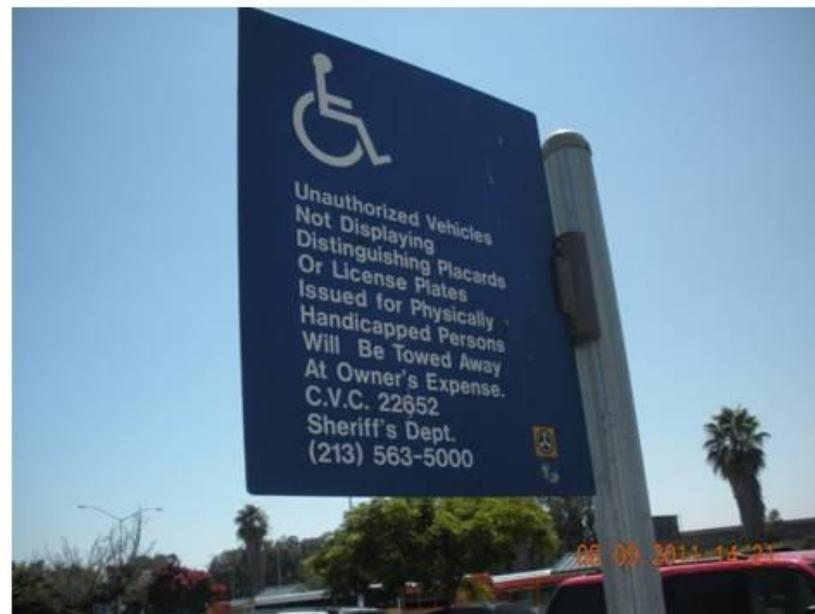
Handicap Parking Warning Signs

All signs state the same message, but are of different colors and use different wording. All signs state the message that "Unauthorized vehicles parked in designated accessible spaces not displaying distinguishing placards or special license plates issued for persons with disabilities will be towed away at owner's expense"

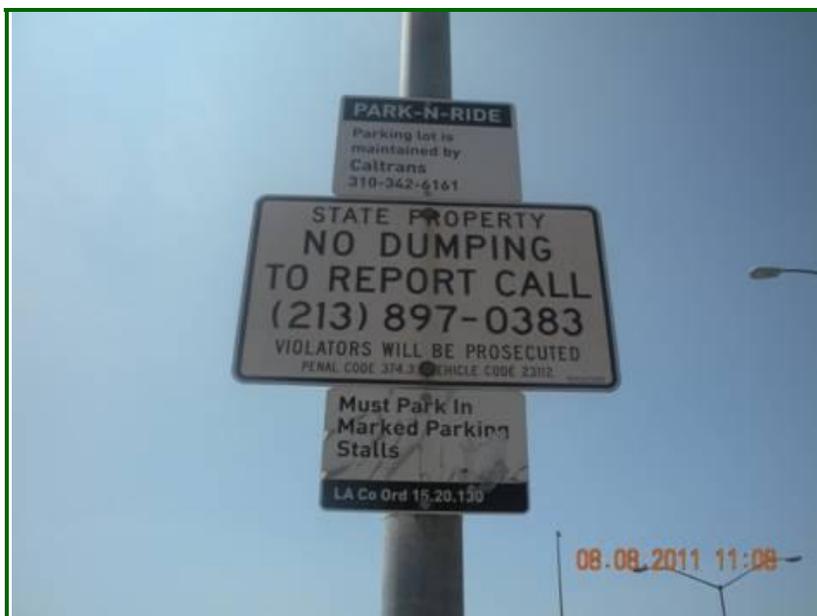
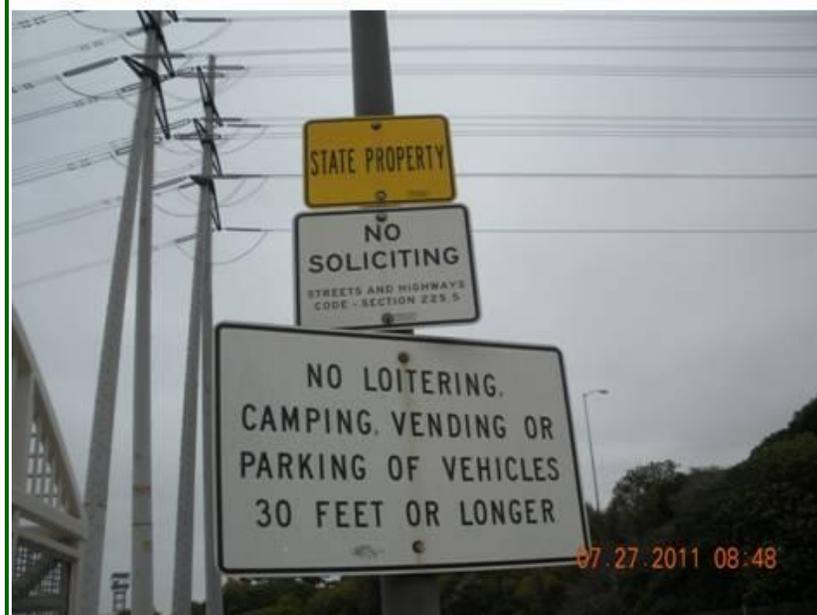
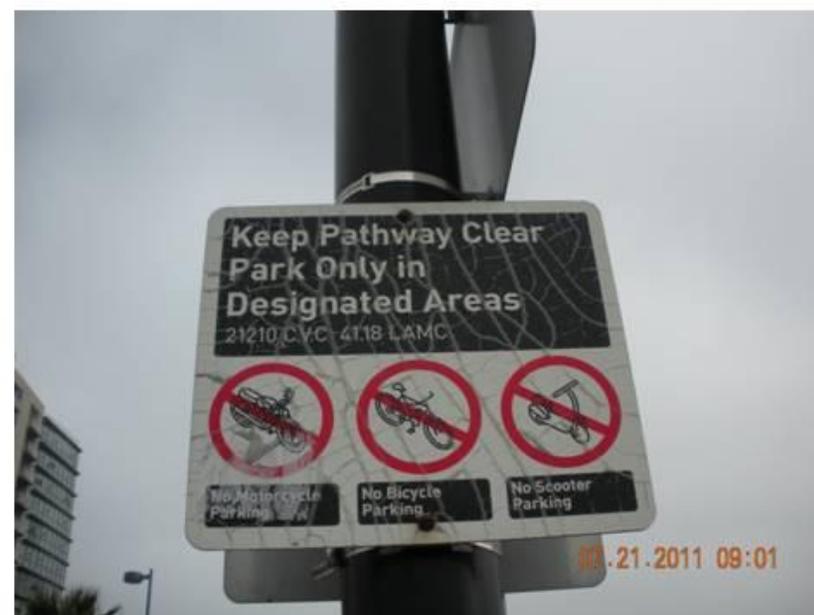
Parking Lot Rules Signs

(Top left picture) Shows three signs; top sign states "Park-N-Ride, Parking lot is maintained by Caltrans," middle sign states "State Property, No Dumping, To Report Call," and the bottom sign states "Must Park In Marked Parking Stalls"

(Bottom left picture) Shows three signs; top sign states "State Property," middle sign states "No Soliciting," and the bottom sign states "No Loitering, Camping, Vending or Parking of Vehicles 30 Feet or Longer"

(Bottom right picture) Sign states "Keep Pathway Clear, Park Only in Designated Areas, No Motorcycle Parking, No Bicycle Parking, No Scooter Parking"

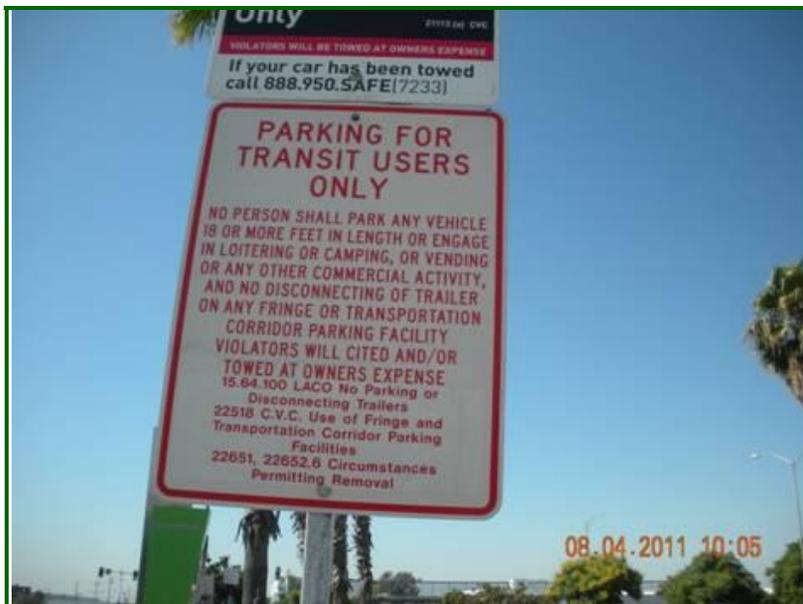
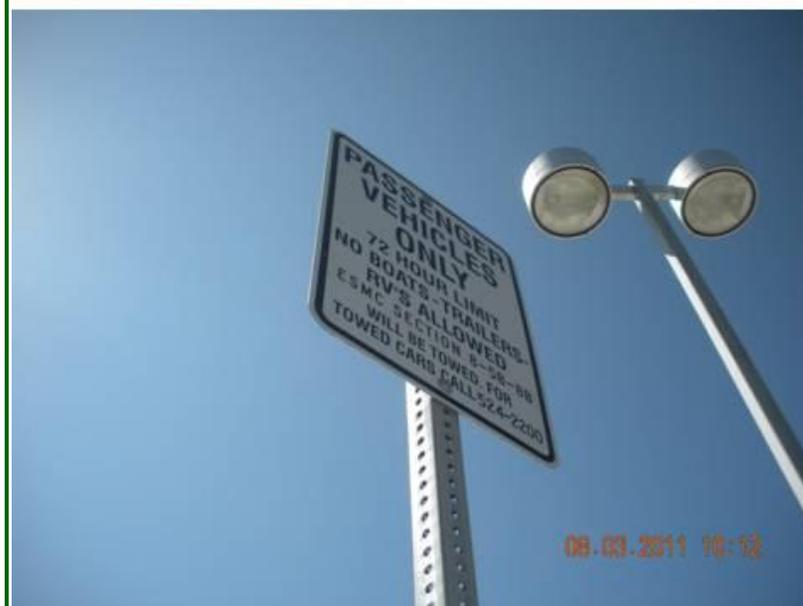
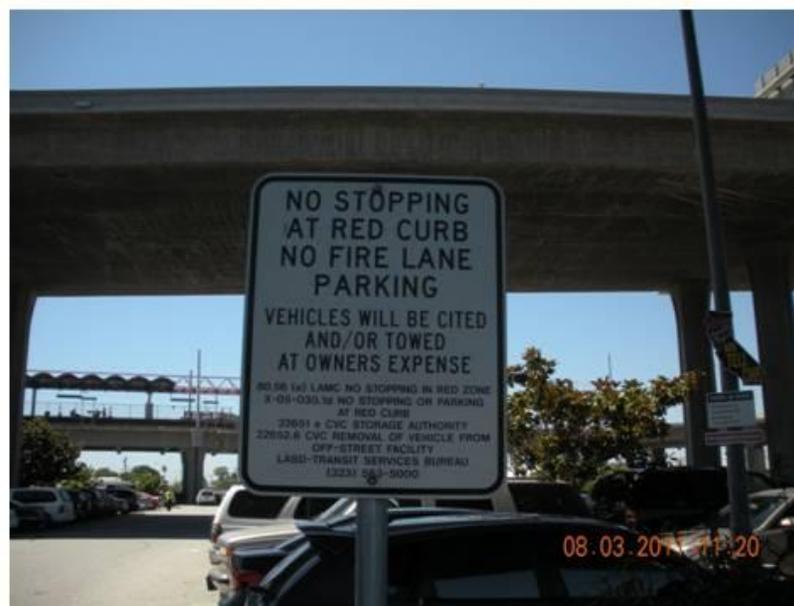
Parking Lot Rules

(Top left picture) Sign states "Parking For Transit Users Only, No person shall park any vehicle 18 or more feet in length or engage in loitering or camping, or vending or any other commercial activity, and no disconnecting of trailer on any fringe or transportation corridor parking facility, violators will be cited and/or towed at owners expense"

(Bottom left picture) Sign states "Passenger Vehicles Only, 72 Hour Limit, No Boats-Trailers-RV's Allowed"

(Bottom right picture) Sign states "No Stopping At Red Curb, No Fire Lane Parking, vehicles will be cited and/or towed at owners expense"

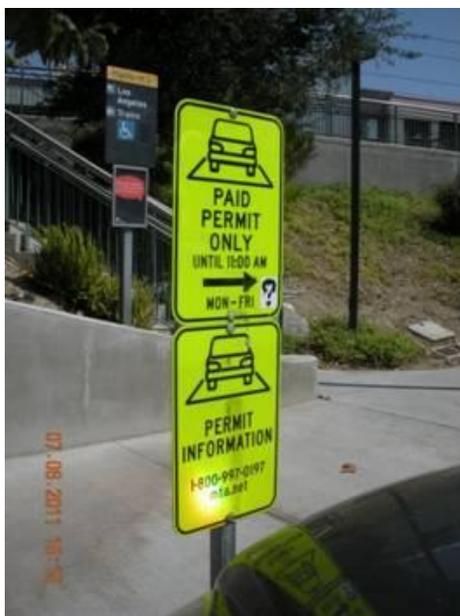
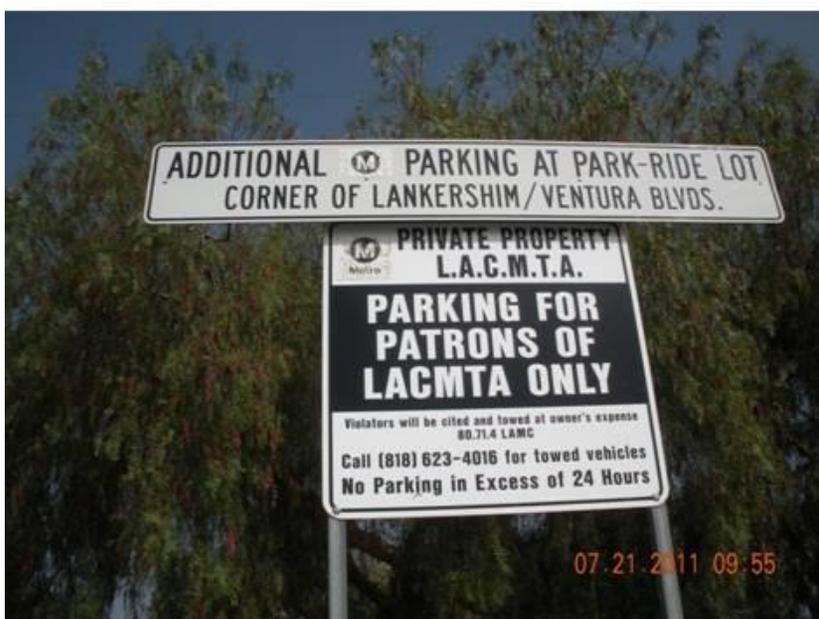
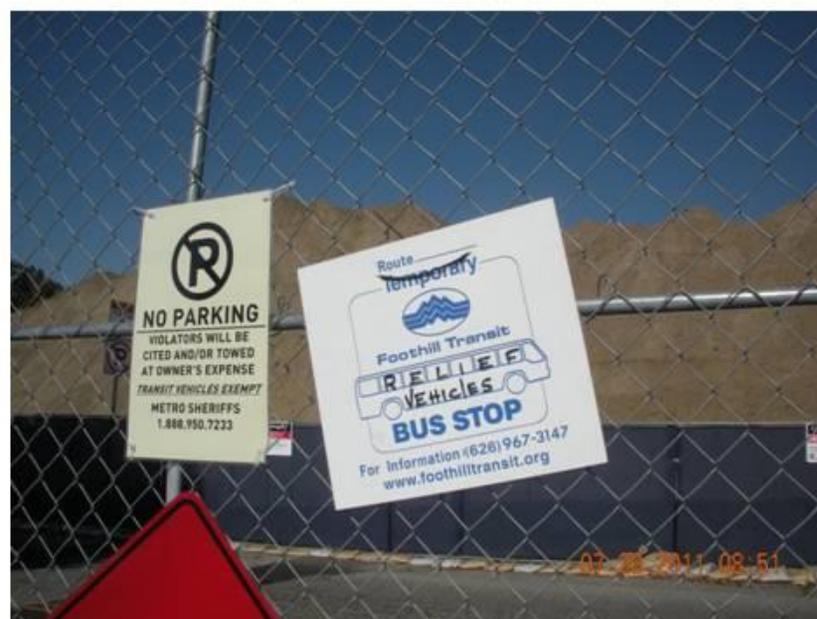
Miscellaneous Parking Signs

(Top left picture) Paid permit signs, top sign states “Paid Permit Only Until 11:00 AM Mon-Fri” and bottom sign states “Permit Information”

(Bottom left picture) Shows two sign; top sign states “Additional Parking at Park-Ride Lot Corner of Lankershim/Ventura Blvds,” and the bottom sign states “Private Property L.A.C.M.T.A., Parking for Patrons of LACMTA Only, Violators will be cited and towed at owner’s expense”

(Bottom right picture) Shows two sign; left sign states “No Parking, Violators will be cited and/or towed at owner’s expense, transit vehicles exempt” and right sign states “Foothill Transit Relief Vehicles Bus Stop”
